Final Project Report:

PV and Advanced Energy Storage for Demand Reduction

SunPower Corp.

Sunpower/ZBB Energy Storage System AT UCSD – Unit #3 LEAK Report

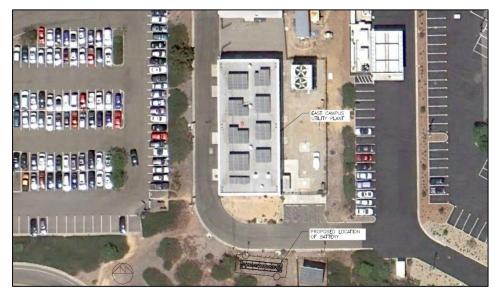
conducted and, agreed upon by all the stakeholders. The team selected an area adjacent to one of UCSD's main utility sites on the East Campus.

2 UCSD East Campus - Selected ZBB Site

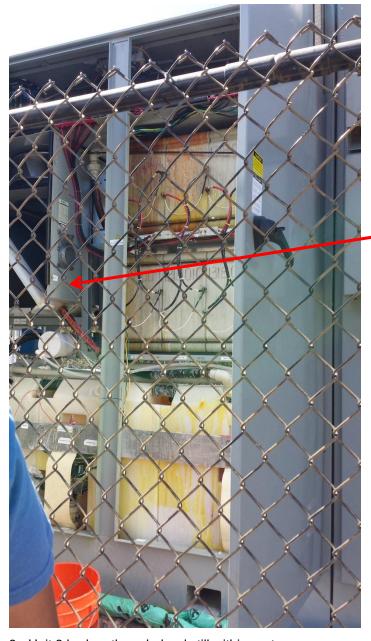
3 - Unit 3 broken threaded rod still within system

Upon initial investigation the noise, and subsequent failure of unit 3, was due to the
failure of the weld on the threaded rod connected to the mounting cylinder that
compressed the battery cell stack together. The leak was at the endplate of the stack,
as the threaded rod no longer compressed the seal.

- Threaded Rod weld to cylinder mount is not rated for pressure of the cell stacks
- Threaded Rod had hair line fracture at the weld from when the unit was dropped and damaged during shipping earlier in the project

- Threaded Rod was rusted due to the caustic environment which weaken the strength below the pressure it was designed to hold
- Cold Weld of the threaded rod head. Note: This is the cause that has been put forth by ZBB.

Broken threaded rod compressing the top cells and leaking of the electrolyte (reddish brown color on left two cells) in Unit 3

- The system should be removed and a thorough engineering analysis of the entire system should be conducted. Analysis should include safety engineering and failure analysis to determine all possible failure modes, risks and mitigation. Some thoughts for the analysis include but should not be limited to:

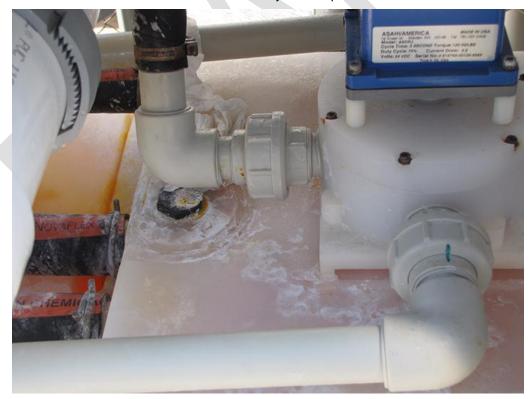
11 - Components after spill with damage

- O Most connections and other metal parts within the ZBB system had discoloration. The discoloration was the color of rust which is very similar to the ZBB electrolyte so it is uncertain if the parts were rusted or just residuals of the earlier leakage in the year. It was noted that the top cover of the 150kva pad mounted transformer for the ZBB system was replaced because of salt air caused rust.

- o Materials used in ZBB system need to be replaced with materials that are resilient to the caustic environment of La Jolla, CA
- Provide door sensors on the doors of the ZBB units such that it will ESTOP that unit
 when it is opened while operating. Allow this sensor to be disabled by a qualified
 ZBB technician when performing diagnostics or permitted energized work
