# HVAC Impact Evaluation FINAL Report

## WO32 HVAC - Volume 2: Appendices

California Public Utilities Commission, Energy Division

Prepared by DNV GL

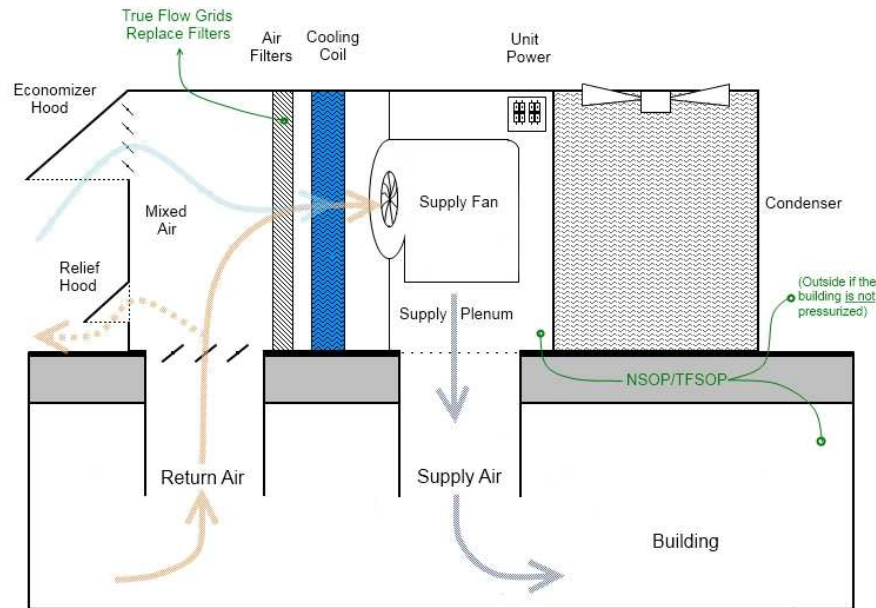
Figure 1: QM True Flow Test Schematic

Figure X demonstrates the critical measurement locations for a TrueFlow test. During a typical TrueFlow test, the evaluation engineer allowed the unit to run in cooling mode for 10 to 15 minutes in order to reach wet coil conditions. Then a measurement of normal static operating pressure (NSOP) was taken. NSOP is the difference between the supply plenum pressure and building pressure (or ambient pressure if a *building is not measurably pressurized*). The unit was then turned off and the air filters were replaced with as many TrueFlow grids as necessary to fill the filter slot. The unit was then turned back on, a TrueFlow static operating pressure reading (TFSOP) was taken (identical to NSOP but with the grids in the filters' place), and airflow through each TrueFlow grid was recorded.

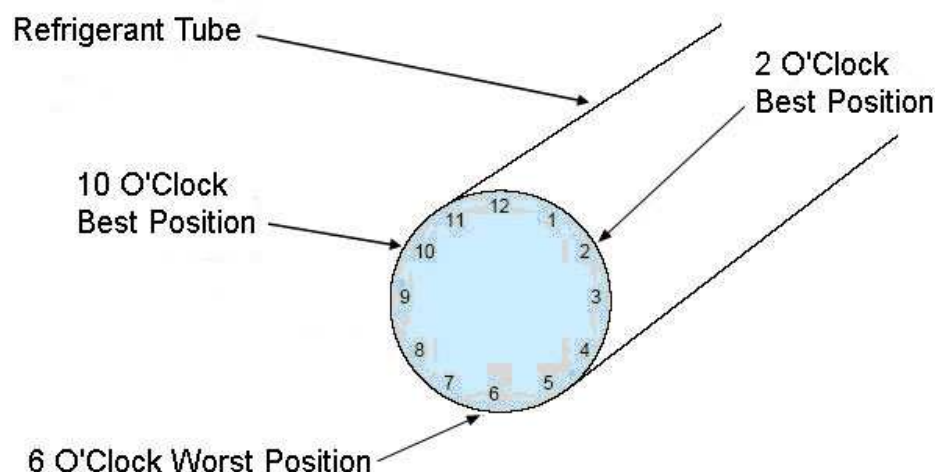
**Figure 5. Best and Worst Positions to Attach Refrigerant Tube Sensors**

Description	Qty.	Labels	Best Tests	Worst Case Tests
1	Type K Clamp 1.25-2.5" dia.	8	A1-A8	10 or 2 o'clock	6 o'clock
2	Type K Clamp 0.375-1.375" dia.	8	B1-B8	10 or 2 o'clock	6 o'clock
3	Type K Clamp 0.375-2.25" dia.	8	C1-C8	10 or 2 o'clock	6 o'clock
4	10K Thermistor Clamp 0.25-1.4" dia	8	D1-D8	10 or 2 o'clock	6 o'clock
5	10K Thermistor velcro strap 3" dia.	7	E1-E7	10 or 2 o'clock	6 o'clock
6	Type K Clamp 0.25-1.375" dia.	8	F1-F8	10 or 2 o'clock	6 o'clock
7	10K Thermistor Clamp 0.375-2.125" dia.	5	G1-G5	10 or 2 o'clock	6 o'clock
9	Type K Clamp 0.25-2.125" dia.	1	I1	10 or 2 o'clock	6 o'clock
10	Type K Clamp 0.25-1.375" dia.	8	J1-J8	10 or 2 o'clock	6 o'clock
11	10K Thermistors 0.1875" x 1.125"	4	K1-K4	10 or 2 o'clock	6 o'clock and no insulation
12	10K Thermistors 0.25" dia. x 1.25"	8	L1-L8	10 or 2 o'clock	6 o'clock and no insulation
13	Type K bead AWG #24	8	N1-N8	10 or 2 o'clock	6 o'clock and no insulation

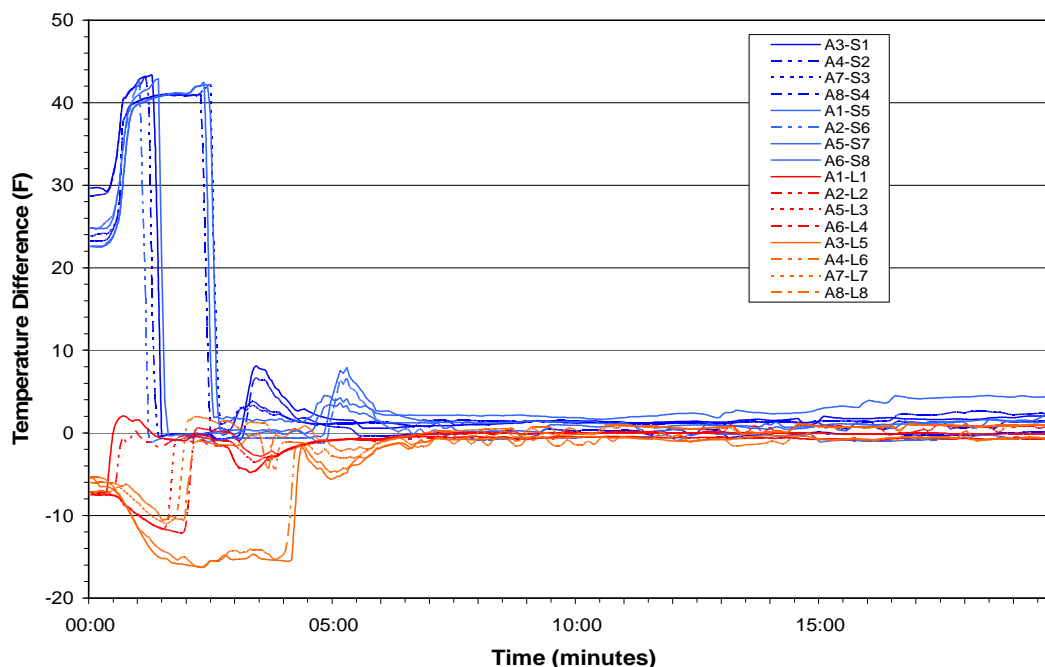
**Figure 6. Type-K Pipe Clamp A1-A8 Temperature Difference at 95°F Ambient**

Preliminary test results for refrigerant tube measurement instruments are shown in **Figures 6** through **13**. The figures show that it can take 5 to 10 minutes or longer for sensors to measure refrigerant temperatures. Tests were conducted with eight sensors on liquid and suction lines. The smallest differences are with specific Type-K clamp probes with accuracy ranging from 1.1 +/- 0.6°F on suction lines at 115°F. Some Type-K clamp probes have suction line accuracy ranging from 6.8 +/- 1.0°F when tested at 115°F outdoor conditions. Differences in accuracy are attributable to design and manufacturing. The largest differences were found with Type-K bead probes and thermistors. Bead probes had differences of 10.7 +/- 3.3°F, cylindrical thermistors had differences of 9.7 +/- 7.1°F, and clamp thermistors had differences of 5.4 +/- 2.1°F. The largest differences are with the suction line measurements where tube temperatures are 25 to

40°F less than ambient. The liquid line temperature is typically 8F to 12F above ambient so there are smaller variations from measured temperatures to actual tube temperatures. It took 15 to 20 minutes to install bead and cylindrical probes and 15 to 20 minutes to bring test chambers to conditions so these probes were on tubes three times longer than clamp probes. Some refrigerant tube tests need to be performed again for consistency in terms of time probes are attached to tubes.

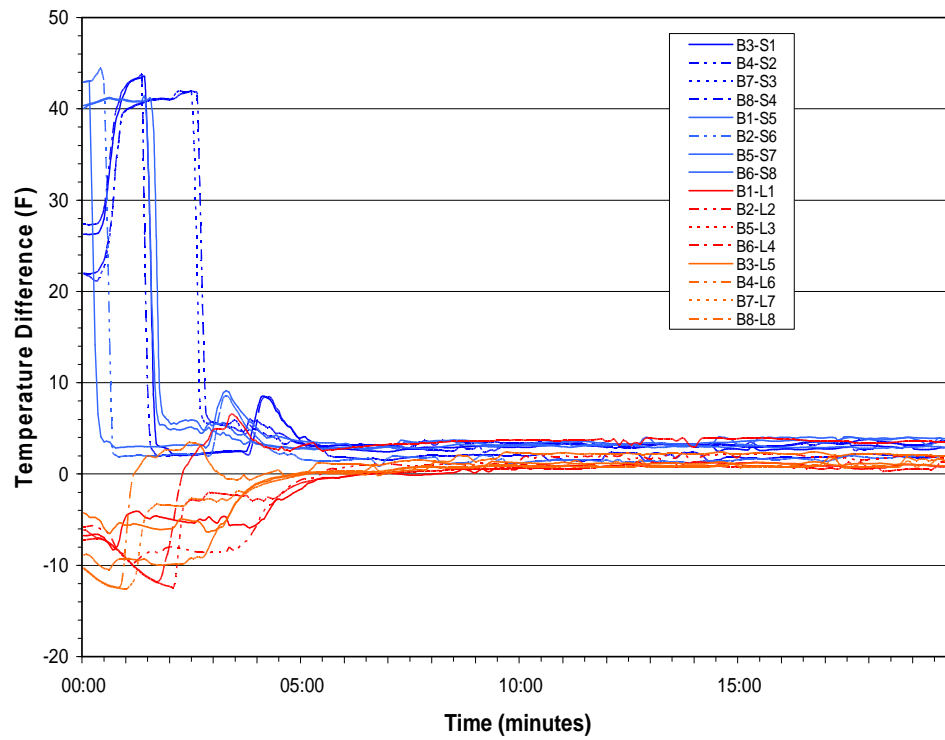
**Figure 7. Type-K Pipe Clamp B1-B8 Temperature Difference at 95°F Ambient**

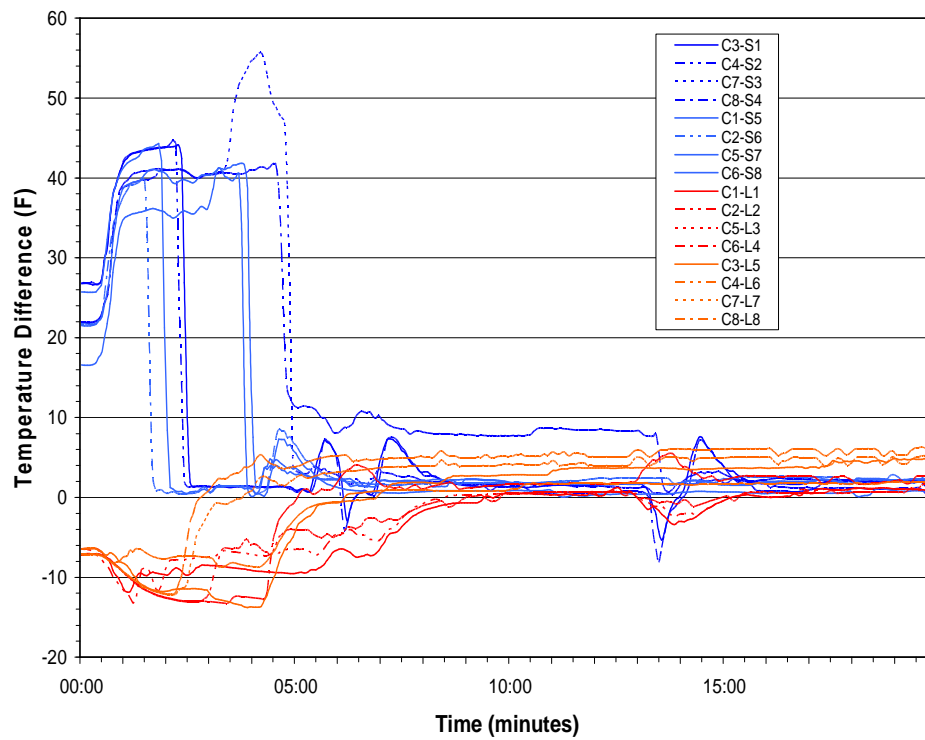
**Figure 8. Type-K Pipe Clamp C1-C8 Temperature Difference at 95°F Ambient**

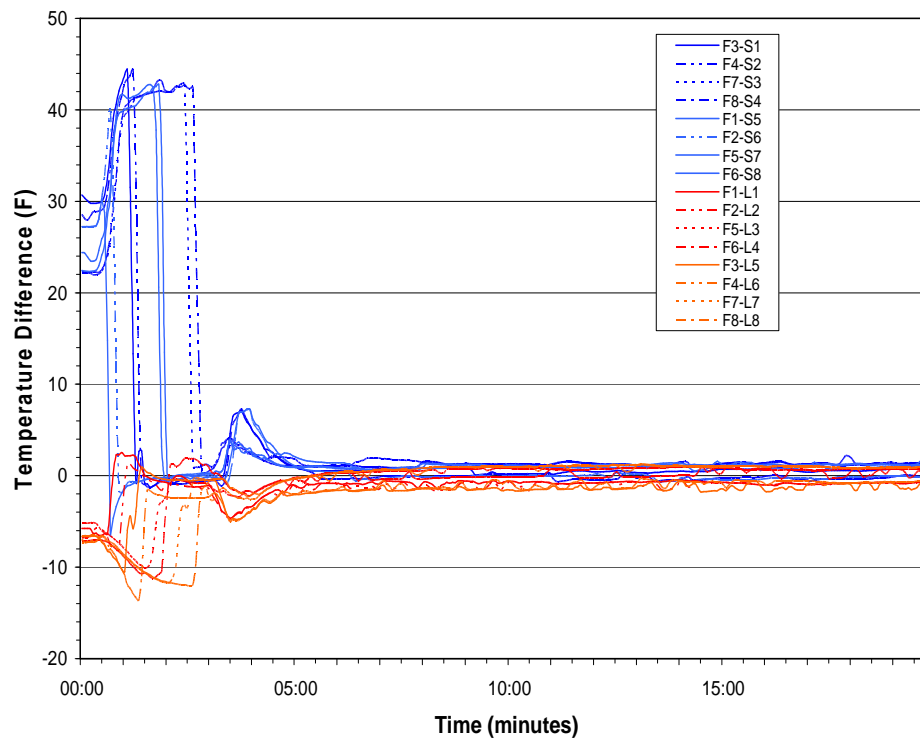
**Figure 9. Type-K Pipe Clamp F1-F8 Temperature Difference at 95°F Ambient**

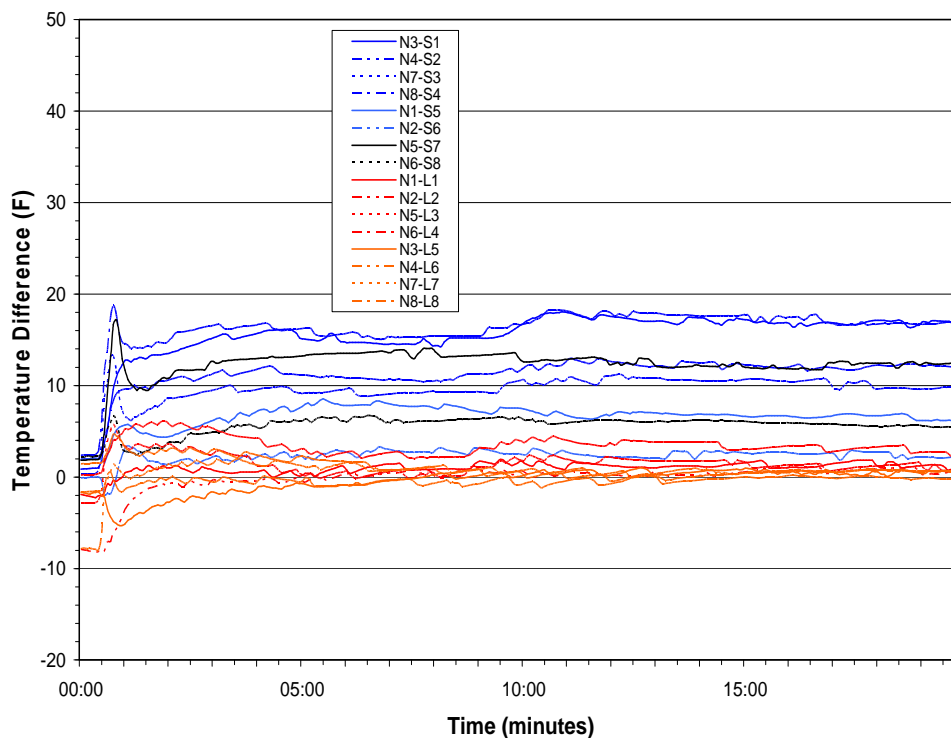
**Figure 10. Type-K Insulated Bead Probes N1-N8 Temperature Difference at 95°F Ambient**

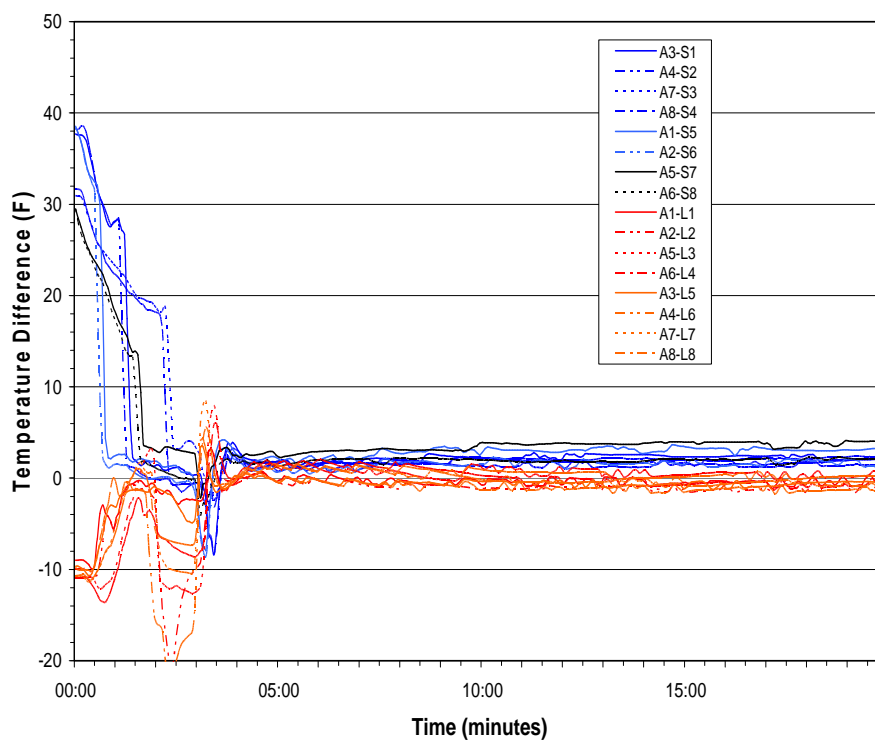
**Figure 11. Type-K Clamp A1-A8 Temperature Difference at 115°F Ambient**

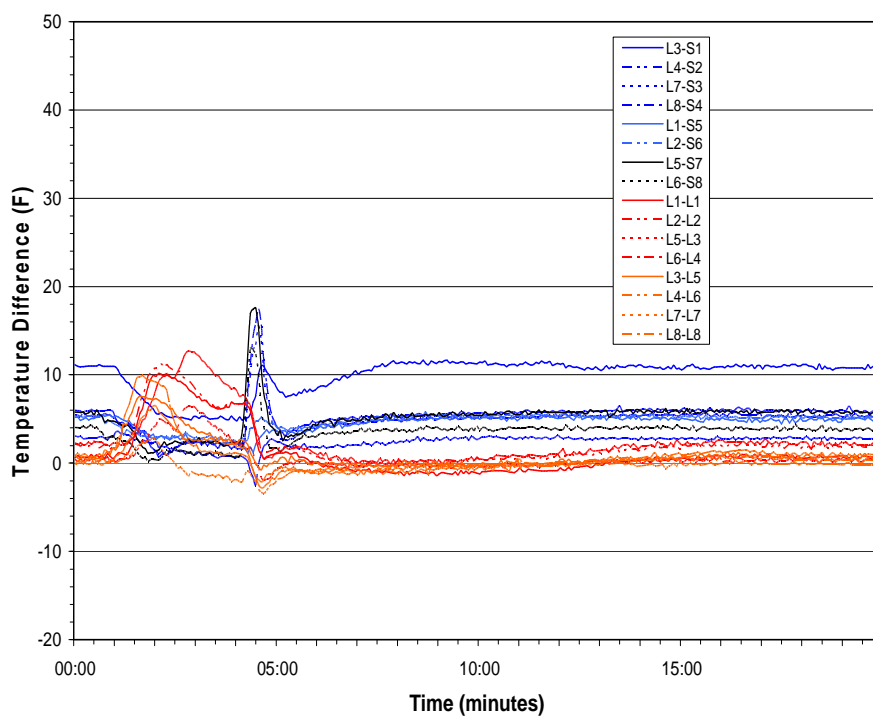
**Figure 12. 10K Thermistor 1/4" Diameter L1-L8 Temperature Difference at 115°F Ambient**

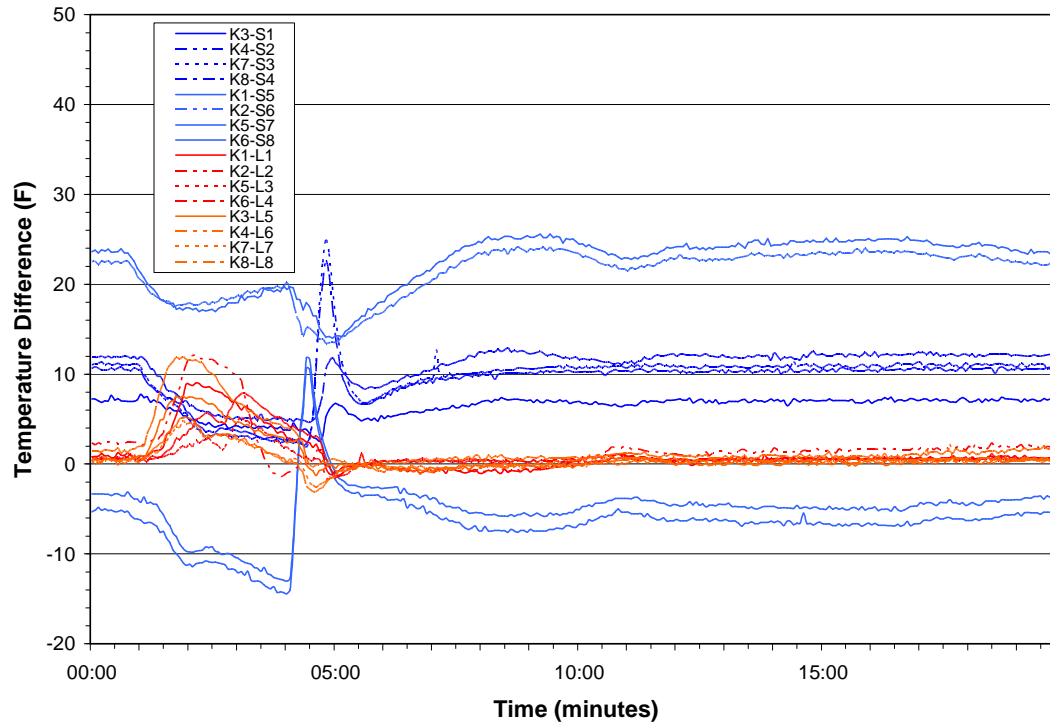
**Figure 2: 10K Thermistor 3/16" Diameter K1-K8 Temperature Difference at 115°F Ambient**
